CONTRACT: INTERMOUNTAIN

THE ENCLOSED DOCUMENTS FORM A RECORD OF MEASUREMENTS TAKEN
DURING STRIPDOWN / REBUILD OF THE MACHINE IDENTIFIED ABOVE

TITLE: 2003 HP REPLANT

Name of Station INTERMOUNTAIN		Unit No: 1		S.T. No: T11246	
Title of Report HP TURBINE REPLANT			Report By W Falconer		
Summary					
<p>The unit was taken out of service on 1st March 2003 for a planned 28 day outage.</p> <p>Work included:-</p> <ul style="list-style-type: none"> • HP turbine rotor and inner shell (cylinder) replacement (upgrade) • IP turbine inspection • Steam admission valves inspection • Limited generator inspection and repair • Extensive boiler inspection and repair • Extensive boiler inspection and modification (upgrade) • Inspection and modification (upgrade) of various auxiliaries including boiler feed pump turbines and main CW cooling <p>This report describes the fitting of the new HP turbine rotor and inner shell.</p> <p>The turbine generator was resynchronised on 29th March 2003, and returned to commercial operation as scheduled.</p> <p>Formal performance tests were carried out during week commencing 7th April 2003. The results confirmed that the guaranteed efficiency had been exceeded.</p> <

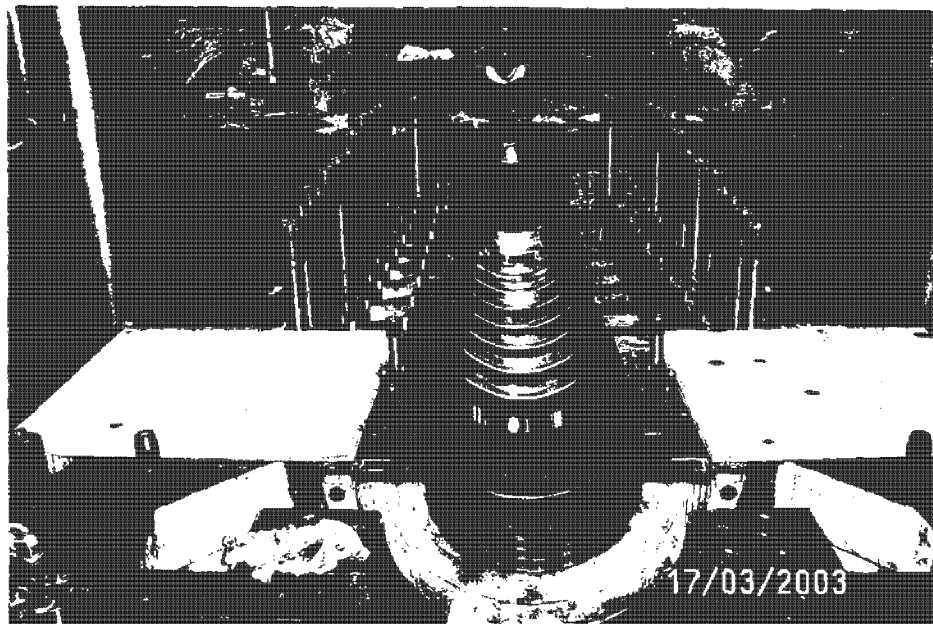
Photograph 8 – BOTTOM HALF INNER CYLINDER IN PLACE

The inner casing lower half was fitted to place followed by the N1 exhaust gland packing head bottom half. Photograph 8. Half joint steps confirmed the correct relative positions of these components were as intended.

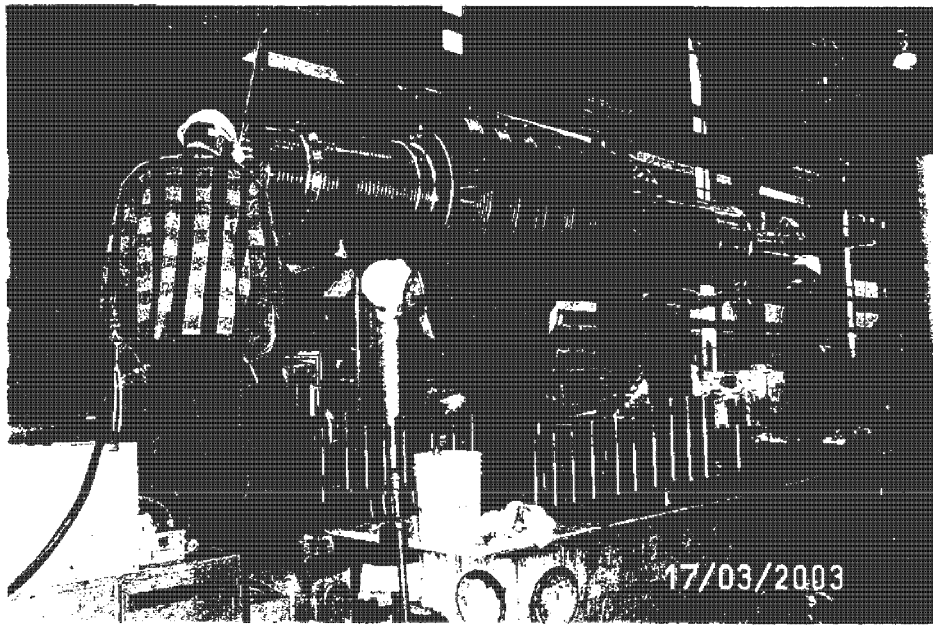
The rotor was fitted (photograph 9) and the vertical position relative to the bottom half inner casing confirmed by bridge datum and by ERAG measurement. With the rotor centralised in the bearings side radial clearances and axial clearances were confirmed to be satisfactory. An unboxed bump check verified the total axial float and touch points in the expanding and contracting directions was as expected. Spot checks were made to confirm the expanding (rotor long) and contracting (rotor short) clearances were to design requirements in both inner and outer shells, with the rotor in cold set position. A 'weight on' HP/IP rotor alignment check was carried out and T2 bearing adjustments made as necessary. The changes in rotor height were subsequently accounted for in the final running key adjustments.

Photograph 9 - ROTOR FINAL ASSEMBLY
